# **Butte Area One Restoration Planning Process and Draft Conceptual Restoration Plan     State of Montana Natural Resource Damage Program**

STATE OF MONTANA'S  
CONCEPTUAL RESTORATION PLAN and PROPOSED PLANNING  
PROCESS FOR BUTTE AREA ONE  
GROUNDWATER AND SURFACE WATER RESOURCES

Prepared by  
Montana Department of Justice

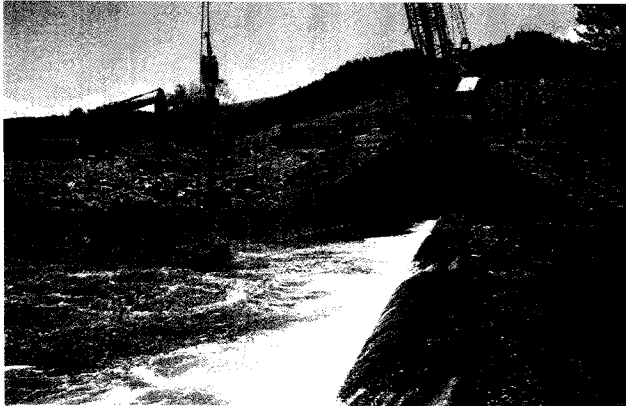
## Photos of Big Hole Diversion Dam

*Showing Installation of Rock Ballast to Repair Undercutting of Dam Structure*

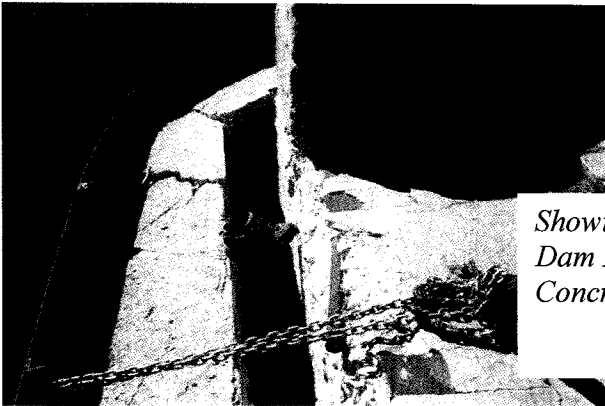
*Showing Poor Condition of Dam Intake Structure Concrete*

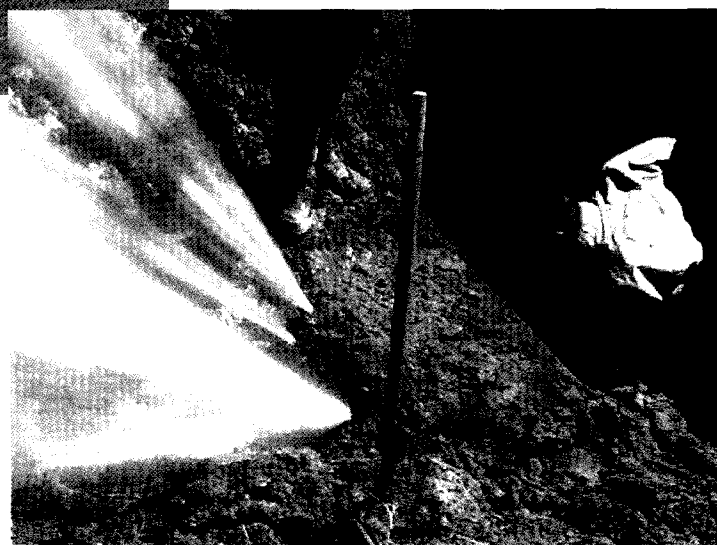
**Photos of Leaks on Big Hole Pipeline**

The 36-inch 19-mile long Big Hole steel transmission main was constructed in the late 1960's and 1970's with steel pipe. The Butte Water System Master Plan prepared in 1988 by James Montgomery Consulting Engineers indicated that the capacity of the transmission main is 17.7 million gallons per day. The Master Plan also stated that at that time the leakage rate of the main was nine percent. Current indications are that the condition of the line is continuing to deteriorate (based on repairs performed by BSB personnel). If this main were to fail, Butte would lose its main source of water until repairs could be made. The typical useful life for a large diameter steel pipeline is 40 years according to *Water Resources and Environmental Engineering* (Linsley/Franzini 3<sup>rd</sup> Edition). Most of the existing pipeline is now about 40 years old. Since 1994, BSB has repaired 250 leaks to the pipeline, this equates to about 20 repairs per year. The average cost of each repair is \$2,000. Photos illustrating the condition of the transmission main have been included below.

The pipeline was coated with very substandard material which consisted of hand painting coal tar on the inside pipe with brushes. The outside of the pipeline was coated only in areas where the pipe was below groundwater. There is no corrosion protection or cathodic protection system installed on the pipeline to protect it from corrosive soils. For these and the above reasons sections of this pipeline needs to be rehabilitated.
